FAILED FULLY-ADHERED ROOF HELD IN PLACE BY 50-POUND BAGS OF CONCRETE

The Achilles Heel of Fully-Adhered Roofs

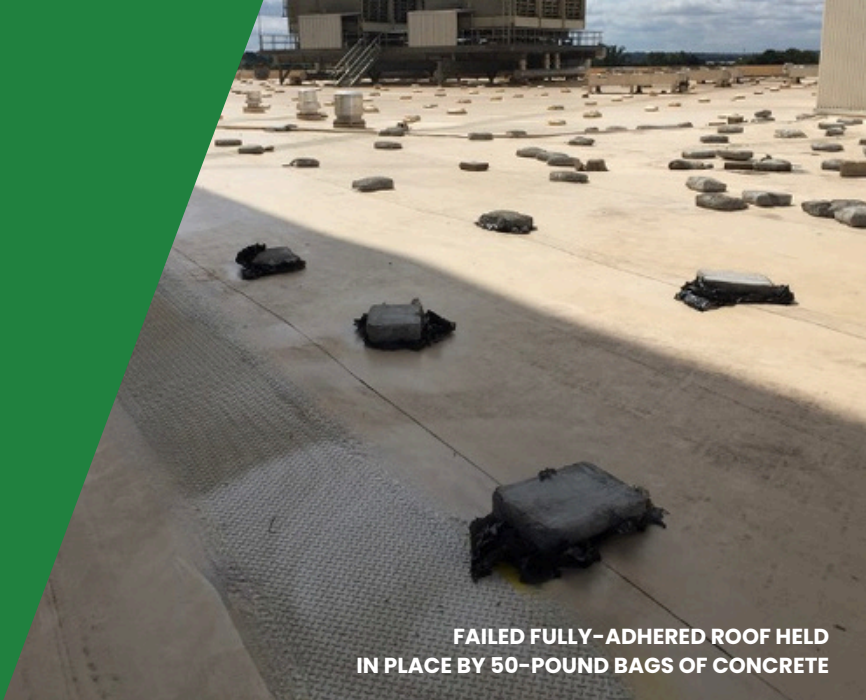
This 140,000 square foot, fully-adhered roof was punctured by falling ice from the adjacent buildings. The concrete roof deck held the water so the punctures were not immediately noticed. The moisture began to degrade the facer on the isocyanurate insulation under the membrane. (Note: In a fully-adhered roof, the facer is adhered to the iso insulation and the membrane is adhered to the facer). Soon, the facer delaminated from the isocyanurate insulation. The membrane was still glued to the facer, but the facer became unadhered to the iso.

Wind over the now loose membrane caused flutter. Flutter caused more delamination. More delamination caused more flutter. Soon, the entire 140,000 square foot roof was ballooning in a wind. Fully-adhered roofs are the “darling” of the roofing industry. But, fully-adhered roofs are the most problematic, the most prone to catastrophic wind damage. The unspoken truth is that the revered fully-adhered assembly depends on a 10 cent per foot facer for survival. The facer is the weakest link and, typically, the point of failure. Introduce moisture to the facer via a puncture and the games begin.
